# SEWER SCOPE INSPECTION

**Inspector Name: Josh Graves**

**Date of Inspection: 1/4/2025**

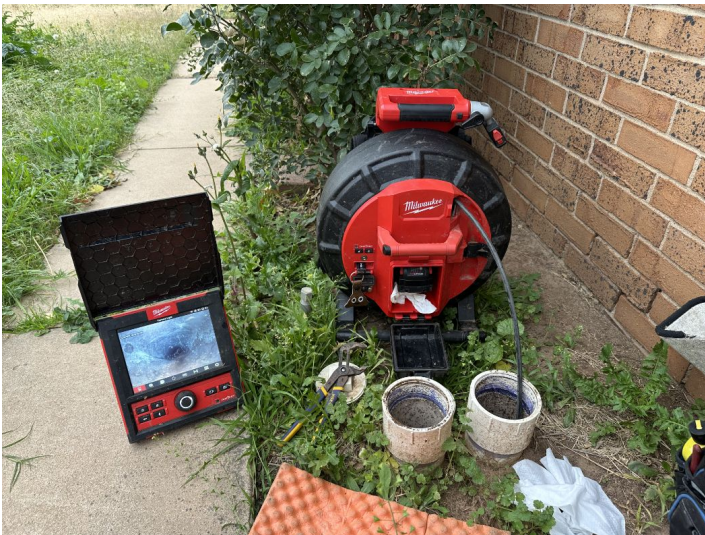
*ran camera from backyard cleanouts*

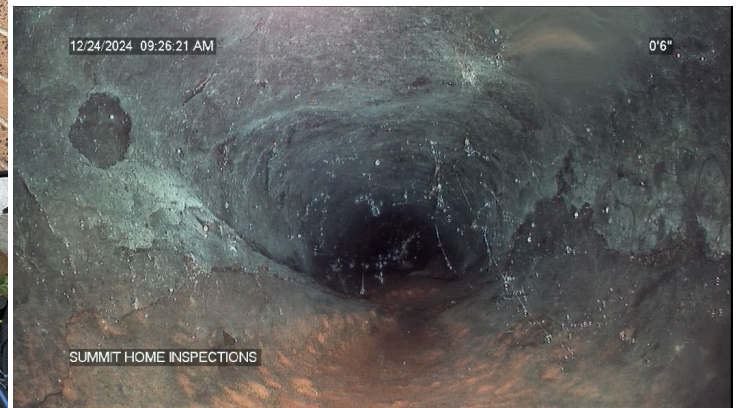
- Orangeburg drain pipe was identified during the sewer scope. Orangeburg pipe was popular in the 1950s and prior and was made from tar impregnated wood pulp. Due to its age and makeup, Orangeburg that is still in use today is often beyond its useful life. Defects common to this type of pipe are: egging/ovaling from pipe compression, delamination/blistering from from the tar wearing out etc. We recommend review by a licensed contractor for repair or replacement as necessary. Repairs may require excavation. **\*\*\*THE ORANGEBURG PIPE WAS IN POOR CONDITION AND SHOULD BE REPLACED IN THE OPINION OF THE INSPECTOR.**

*egging/deformed Orangeburg sewer line thru backyard*

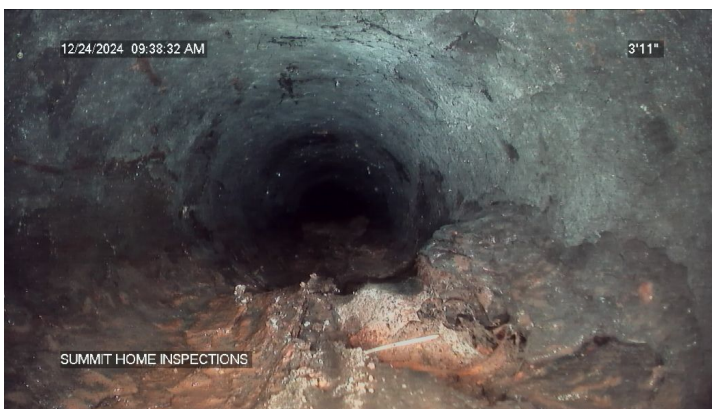
*blistering/deteriorated Orangeburg sewer*

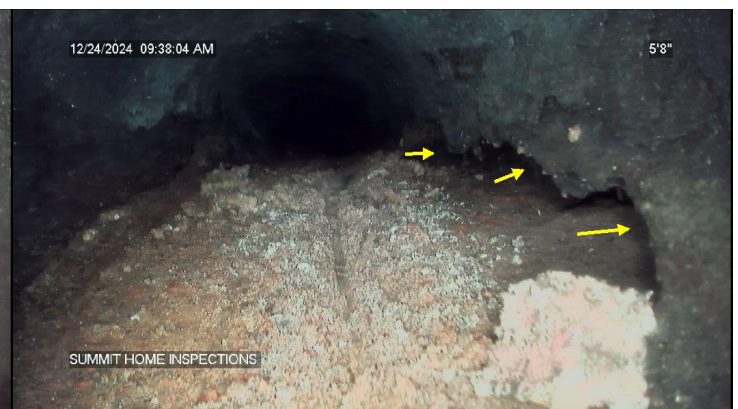
*deterioration at sidewall of Orangeburg sewer*

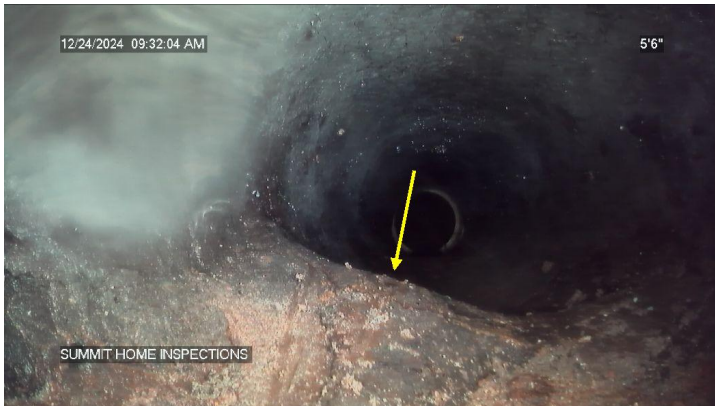
*blistered/warped Orangeburg sewer in backyard*

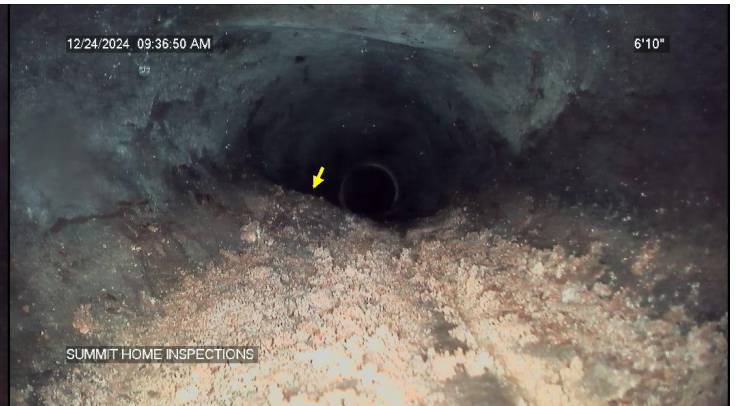
*blistered/warped Orangeburg sewer in backyard*

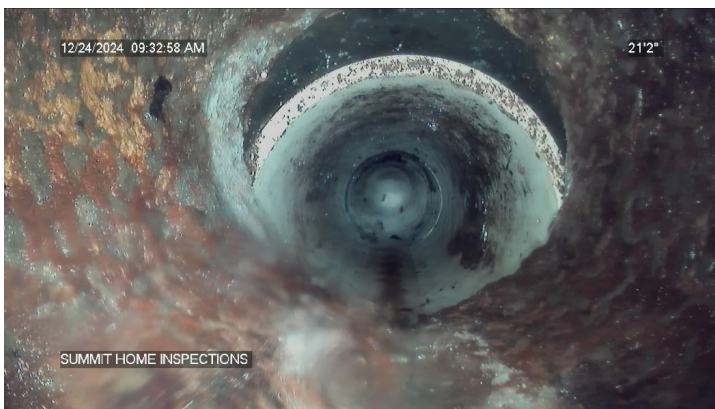
*transitions into PVC pipe for city tap; offset noted*

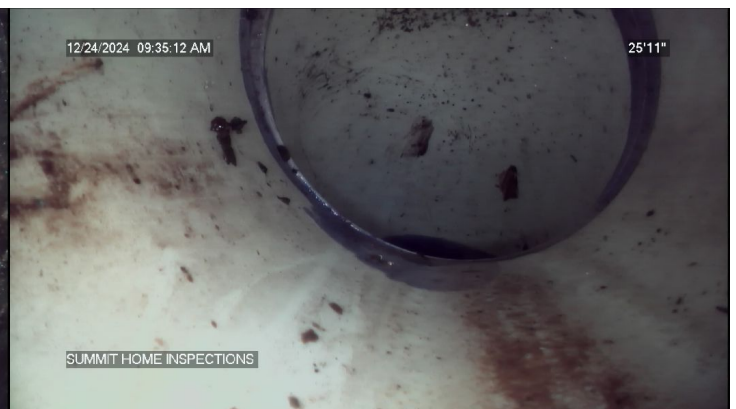
*ran camera DOWN to city tap/main*

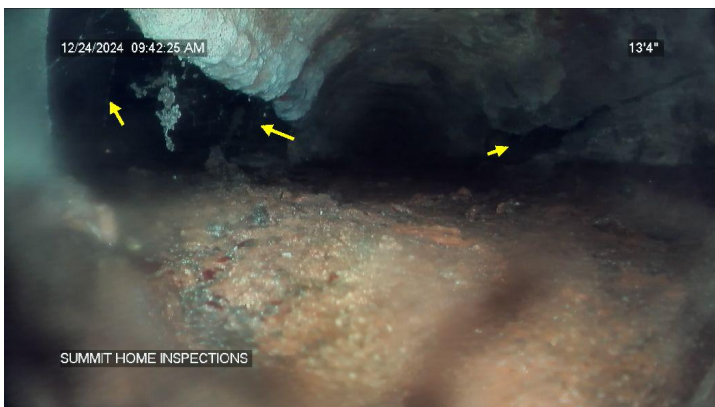
- Cast iron drain pipe was noted with scale/corrosion on the interior walls of the pipe. As cast iron ages, its interior becomes increasingly rough and more prone to catching debris/solids. Additionally, advanced deterioration of the building drain was noted (cracks, rot, etc) and replacement is recommended.

*cast iron building drain (under house/slab) with severe rot/deterioration*

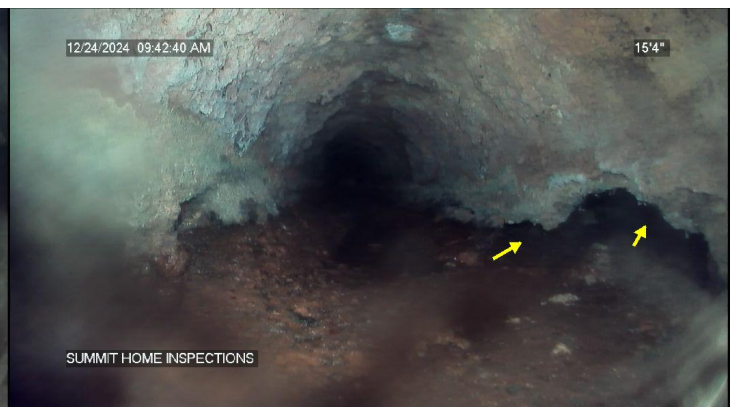
*cast iron building drain (under house/slab) with severe rot/deterioration*

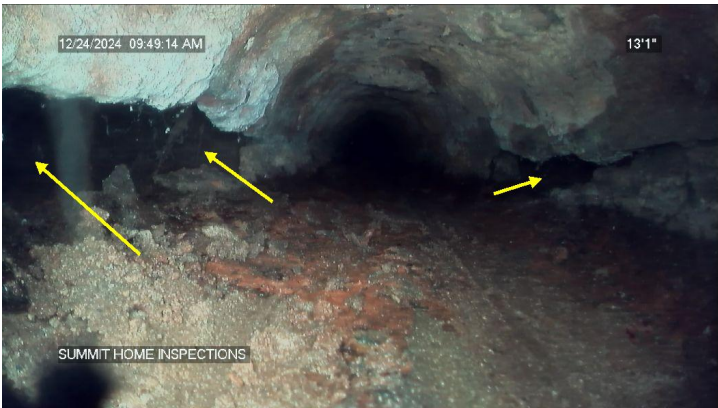
*cast iron rotted out on sides of pipe*

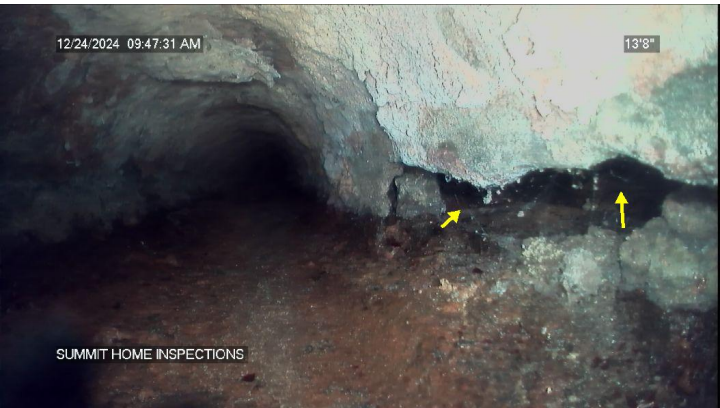
*cast iron building drain (under house/slab) with severe rot/deterioration*

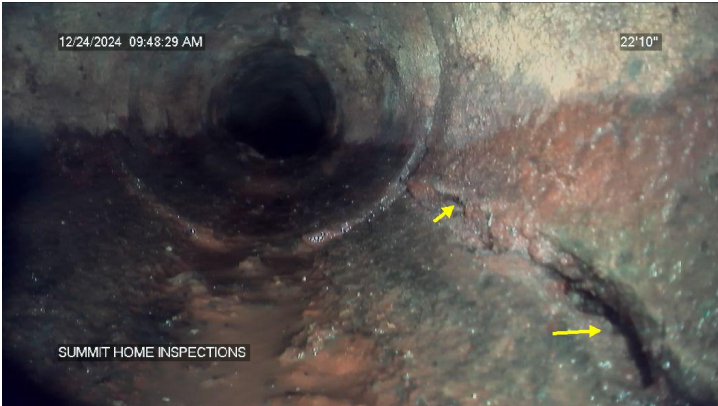
*cracked cast iron under house*

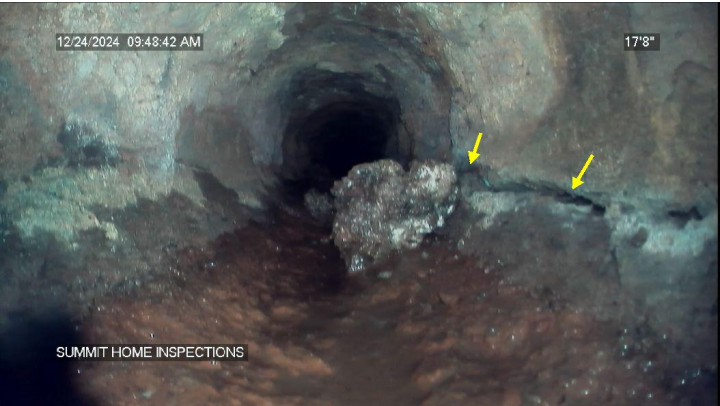
*cracked cast iron under house*

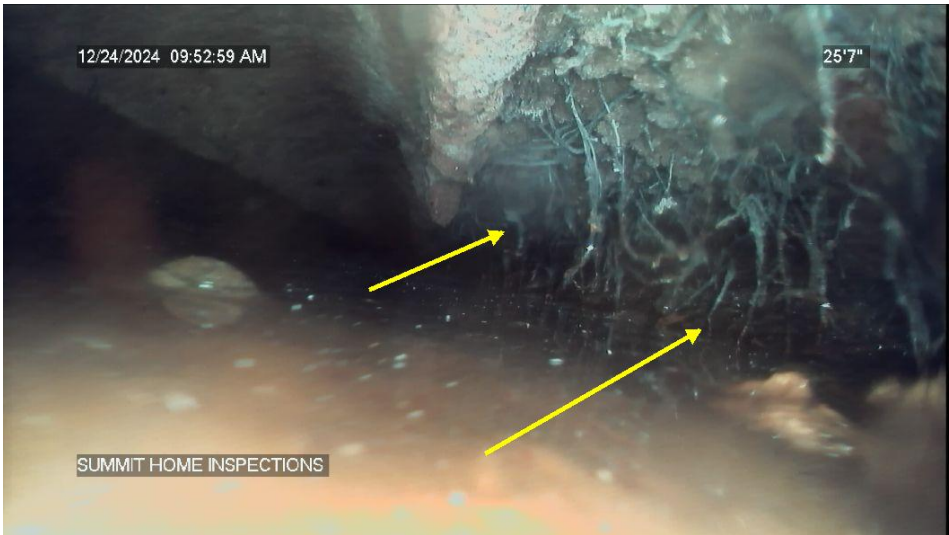
*cast iron rotted out on sides of pipe*
